# Exploded drawings

## Electric and Gas Combisteamer Gold

European CE-Version

2011/10/12 SEV/KA

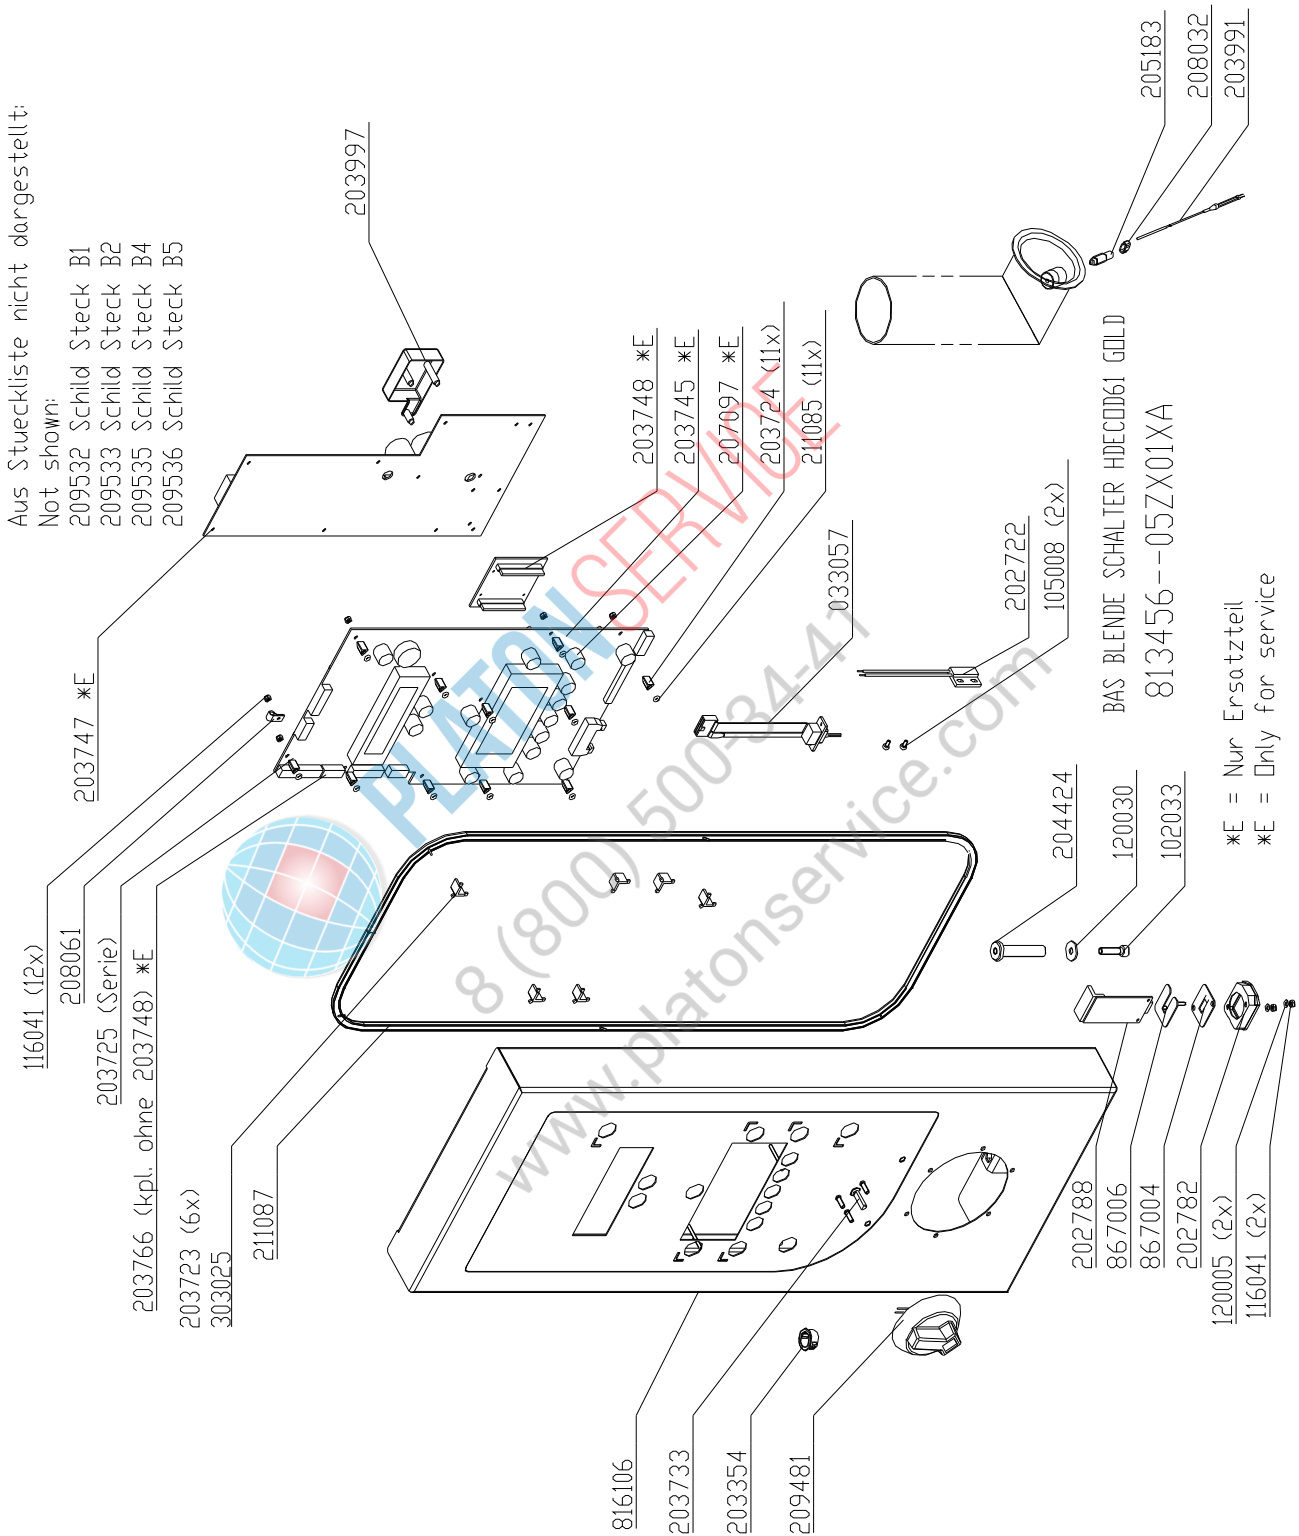
## Front panel HD6.x Gold

Valid from S/N 09021472 (Juli2009) with USB port

Until S/N 09021471 with serial port #033023 instead of USB port

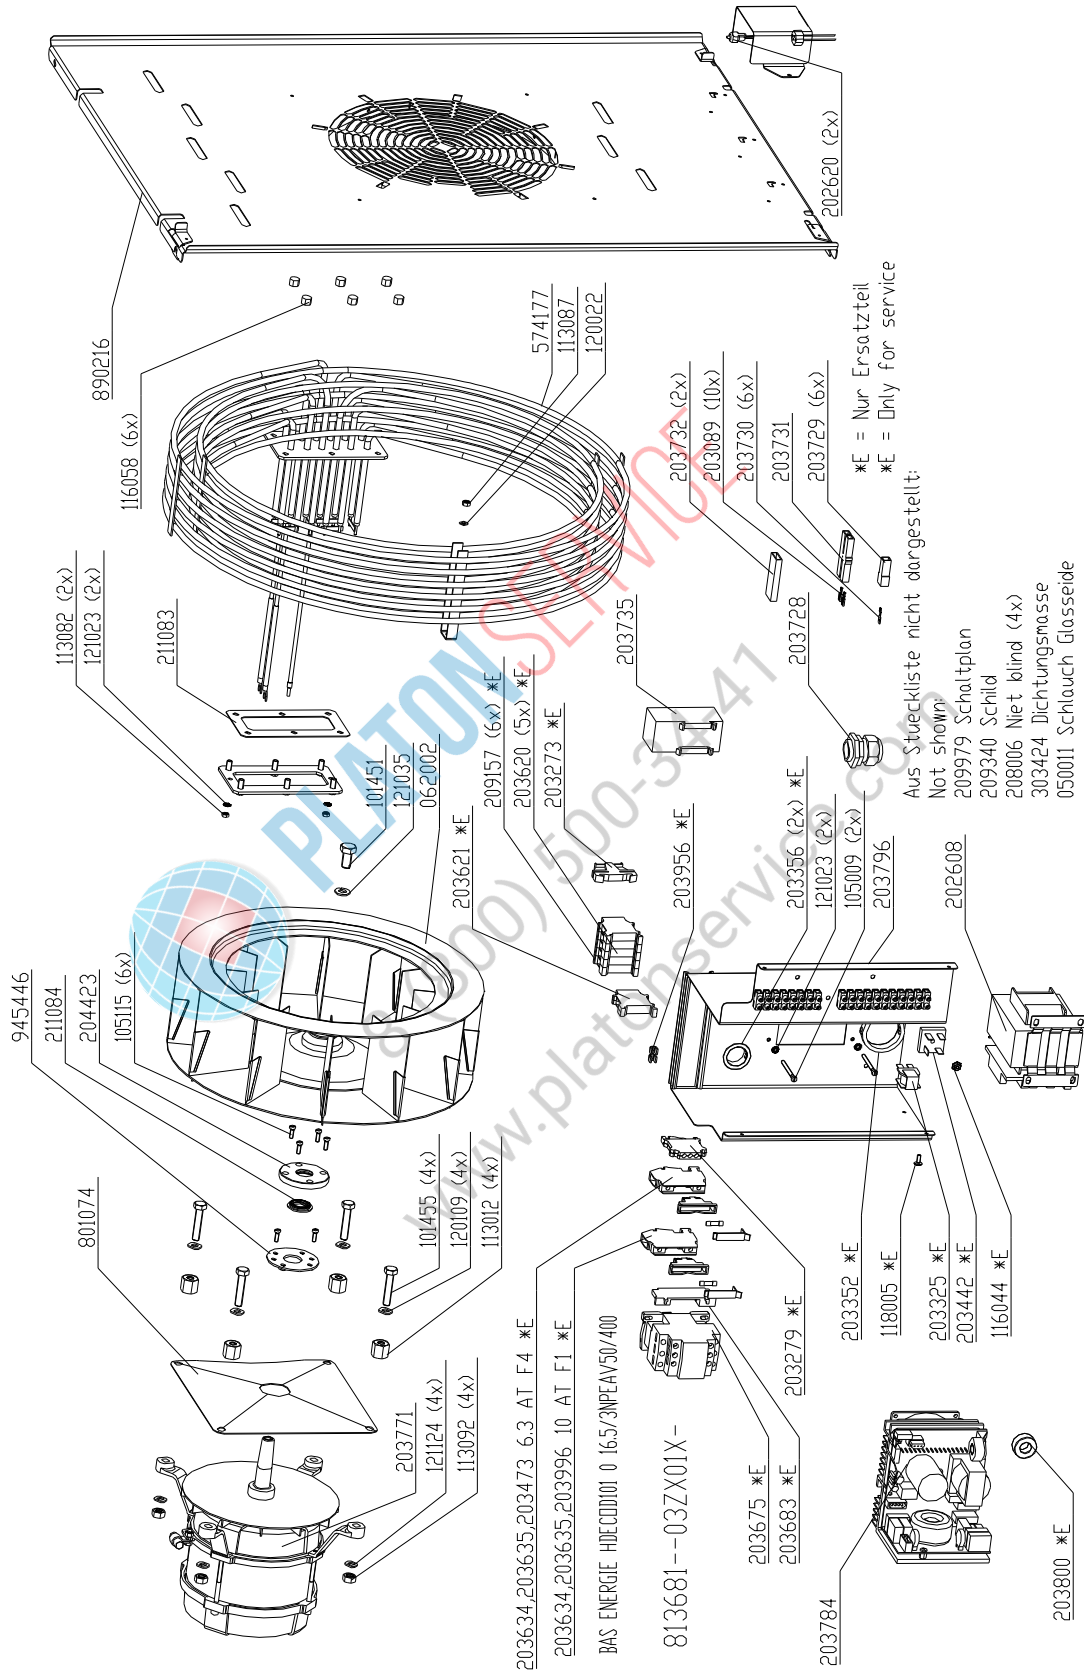
# Electric assembly 3NPE 400V HD10.1

Bis (until) S/N 08022075 (August2008) Transformator (transformer) #203818

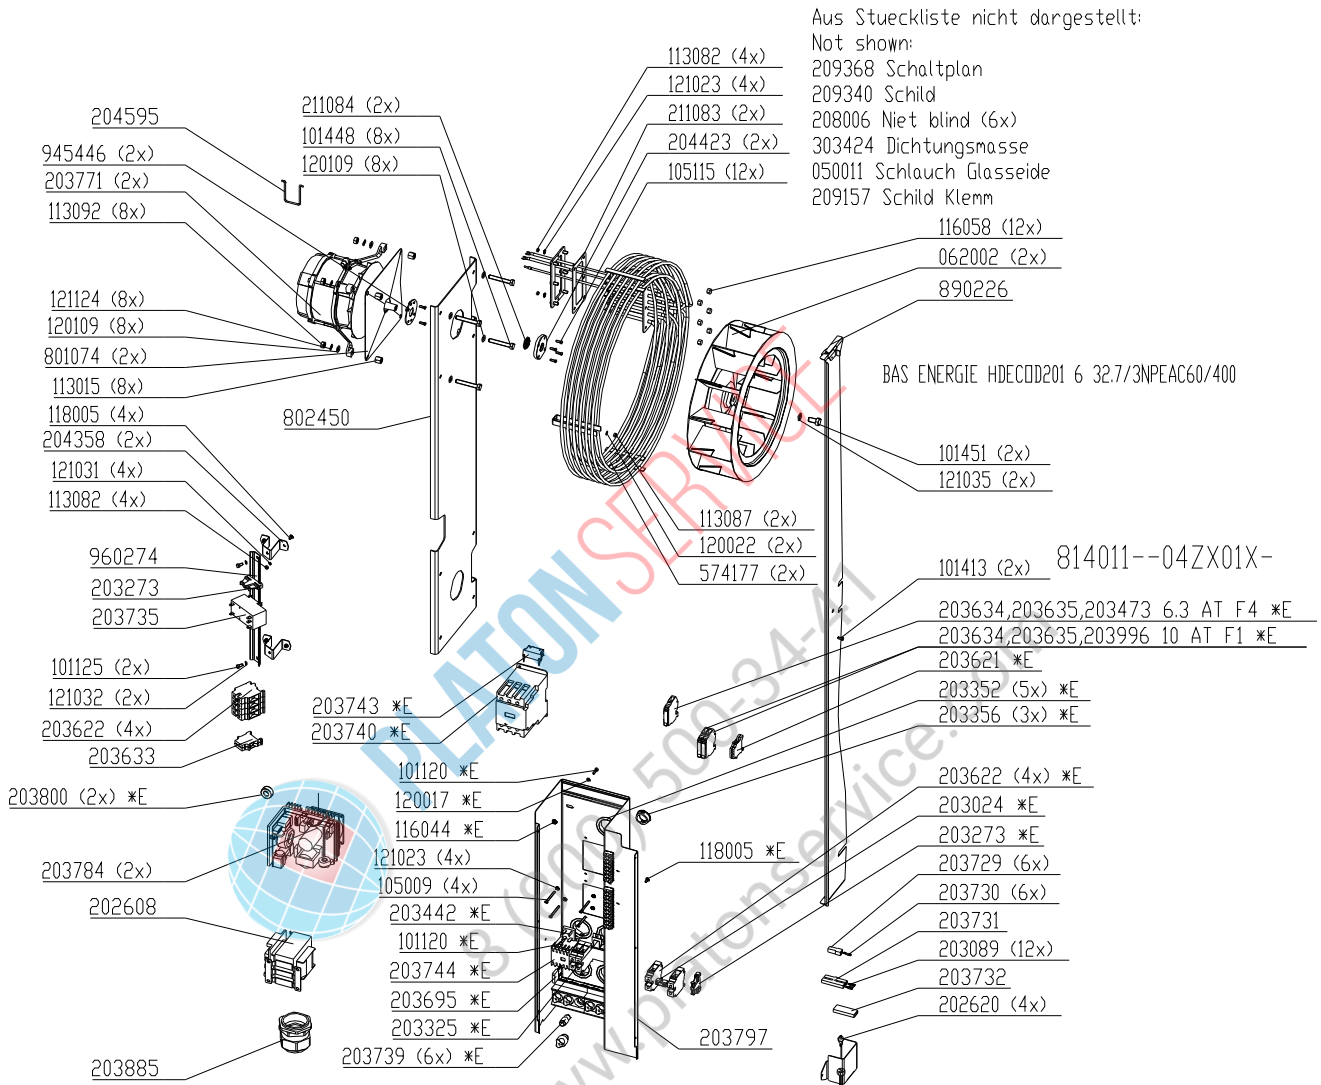
## Electric assembly 3NPEAC 400V HD20.1

Bis (until) S/N 08022075 (August2008) Transformator (transformer) #203818  
Ab (from) S/N 11212250 (October 2011): #945446 → #945661, #204423 → 204681,  
#202620 → #203679
