Exploded drawings

Electric and Gas Combisteamer Silver II

European CE-Version

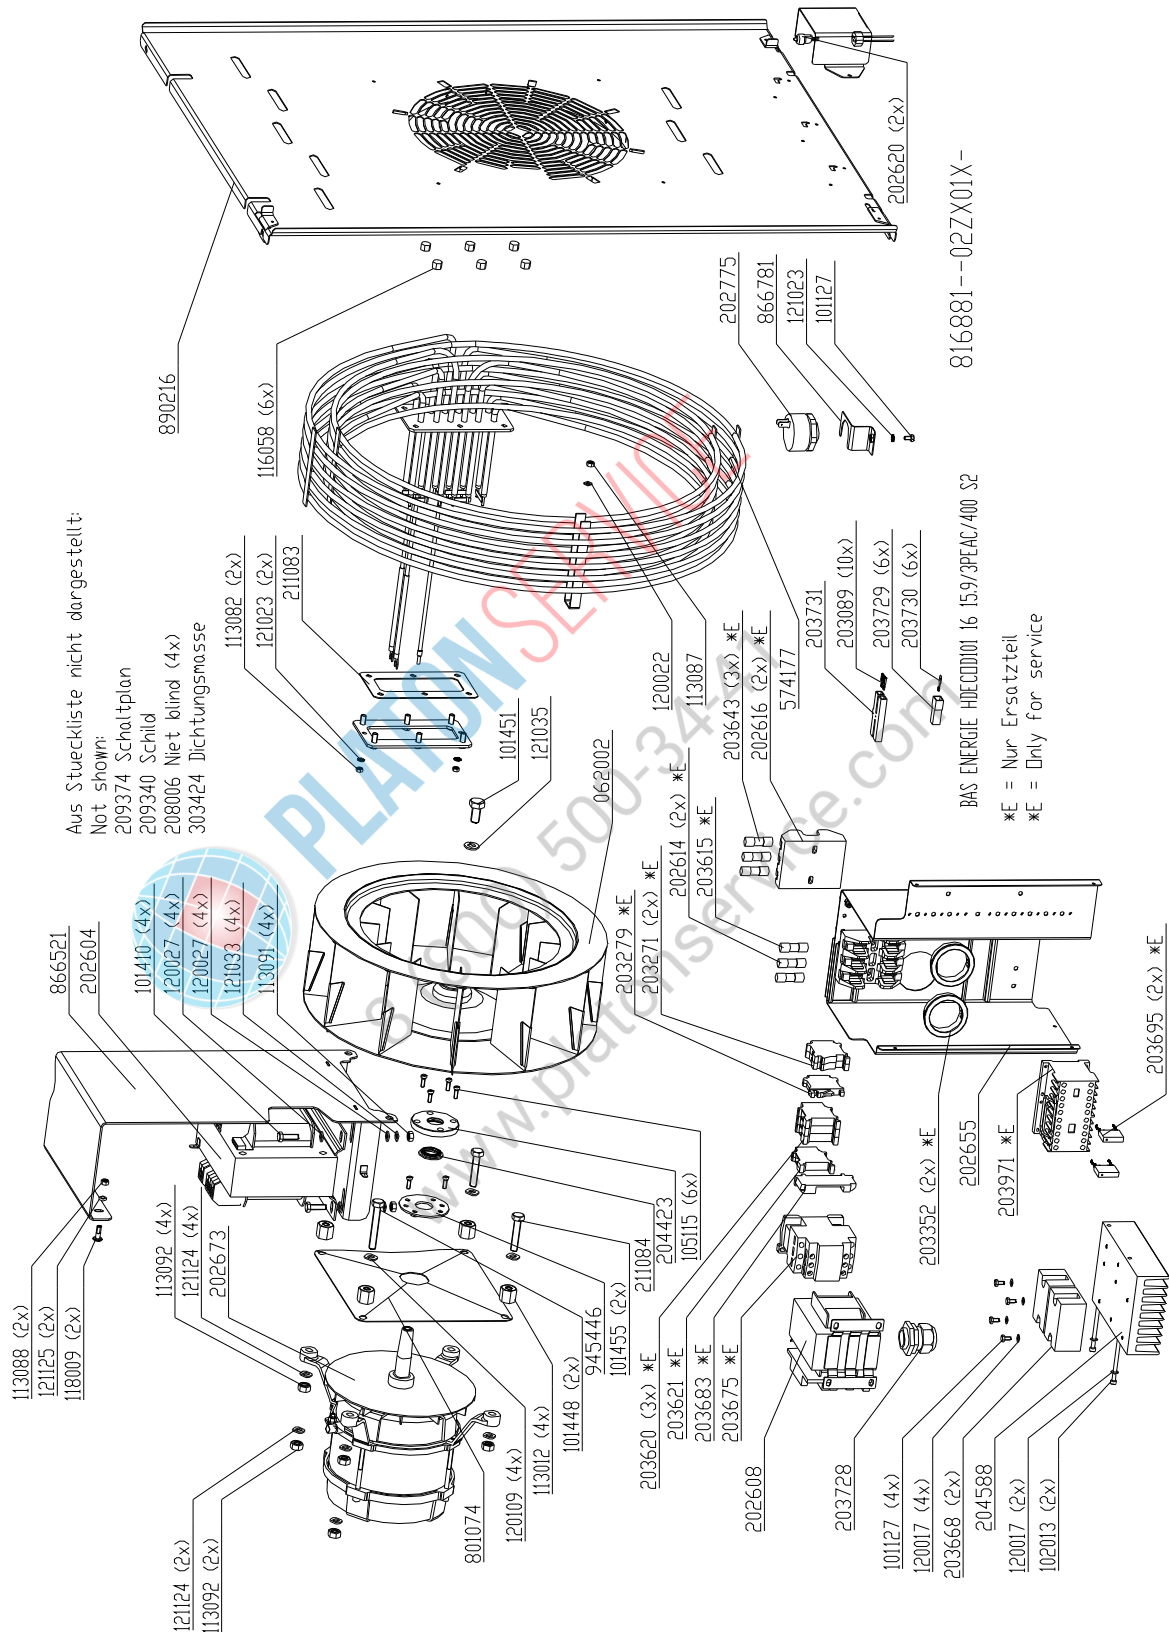
Electric assembly 3NPE 400V HD6.2 Silver2

Bis (until) S/N 08022075 (August2008) Transformator (transformer) #203818
 Ab (from) S/N 11209575 (August2011): #945446 → #945661, #204423 → 204681,
 #202620 → #203679

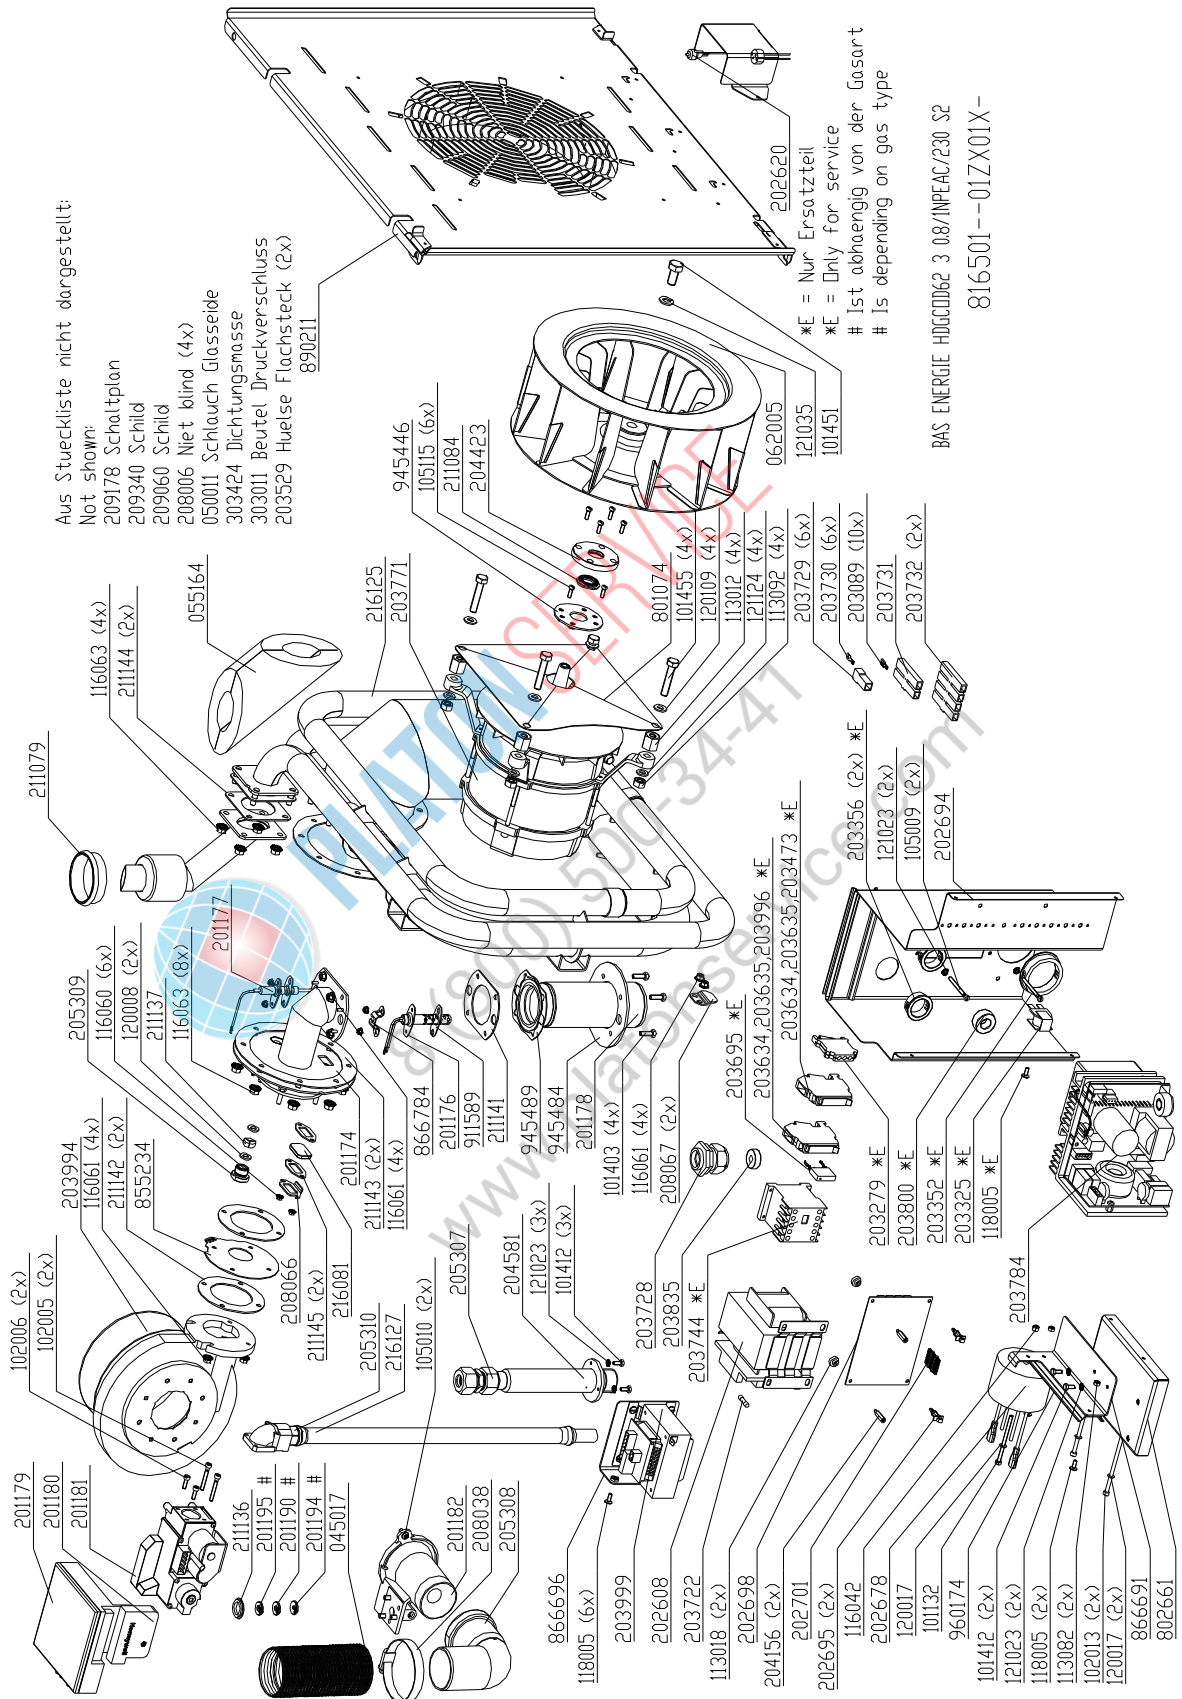
Gas assembly HD6.2 Silver2

Bis (until) S/N 08022075 (August2008) Transformator (transformer) #203818
Ab (from) 11209862 (August2011): #202620 → #203679

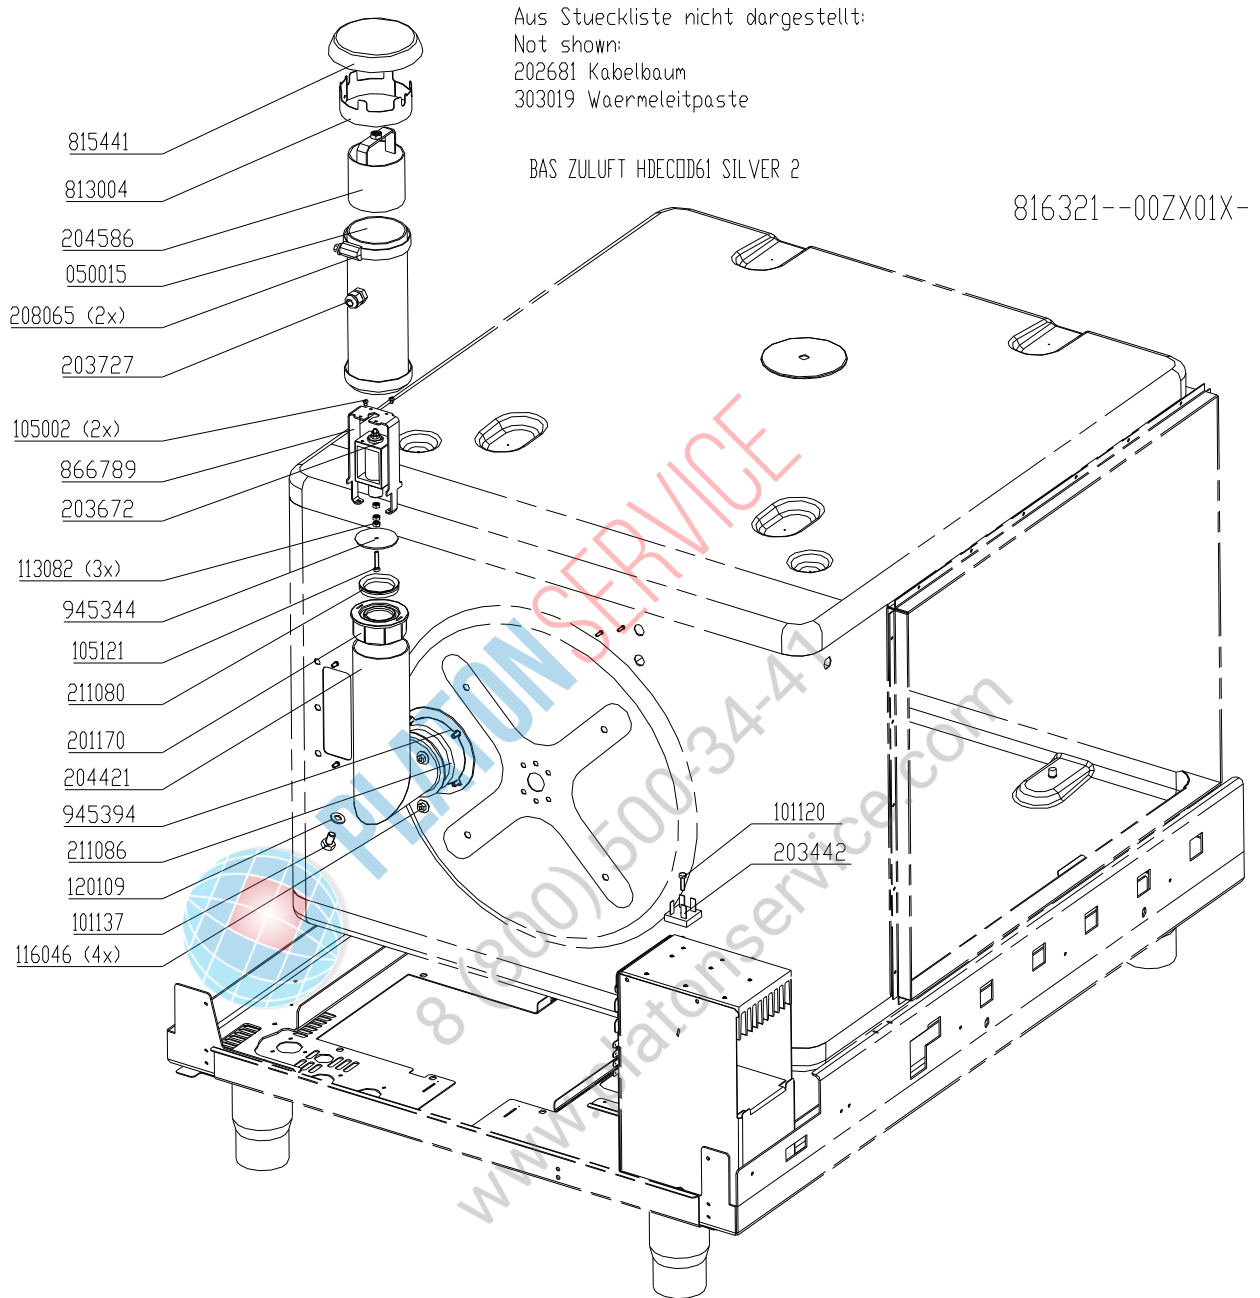
Fresh air assembly 6.x 10.x Silver2

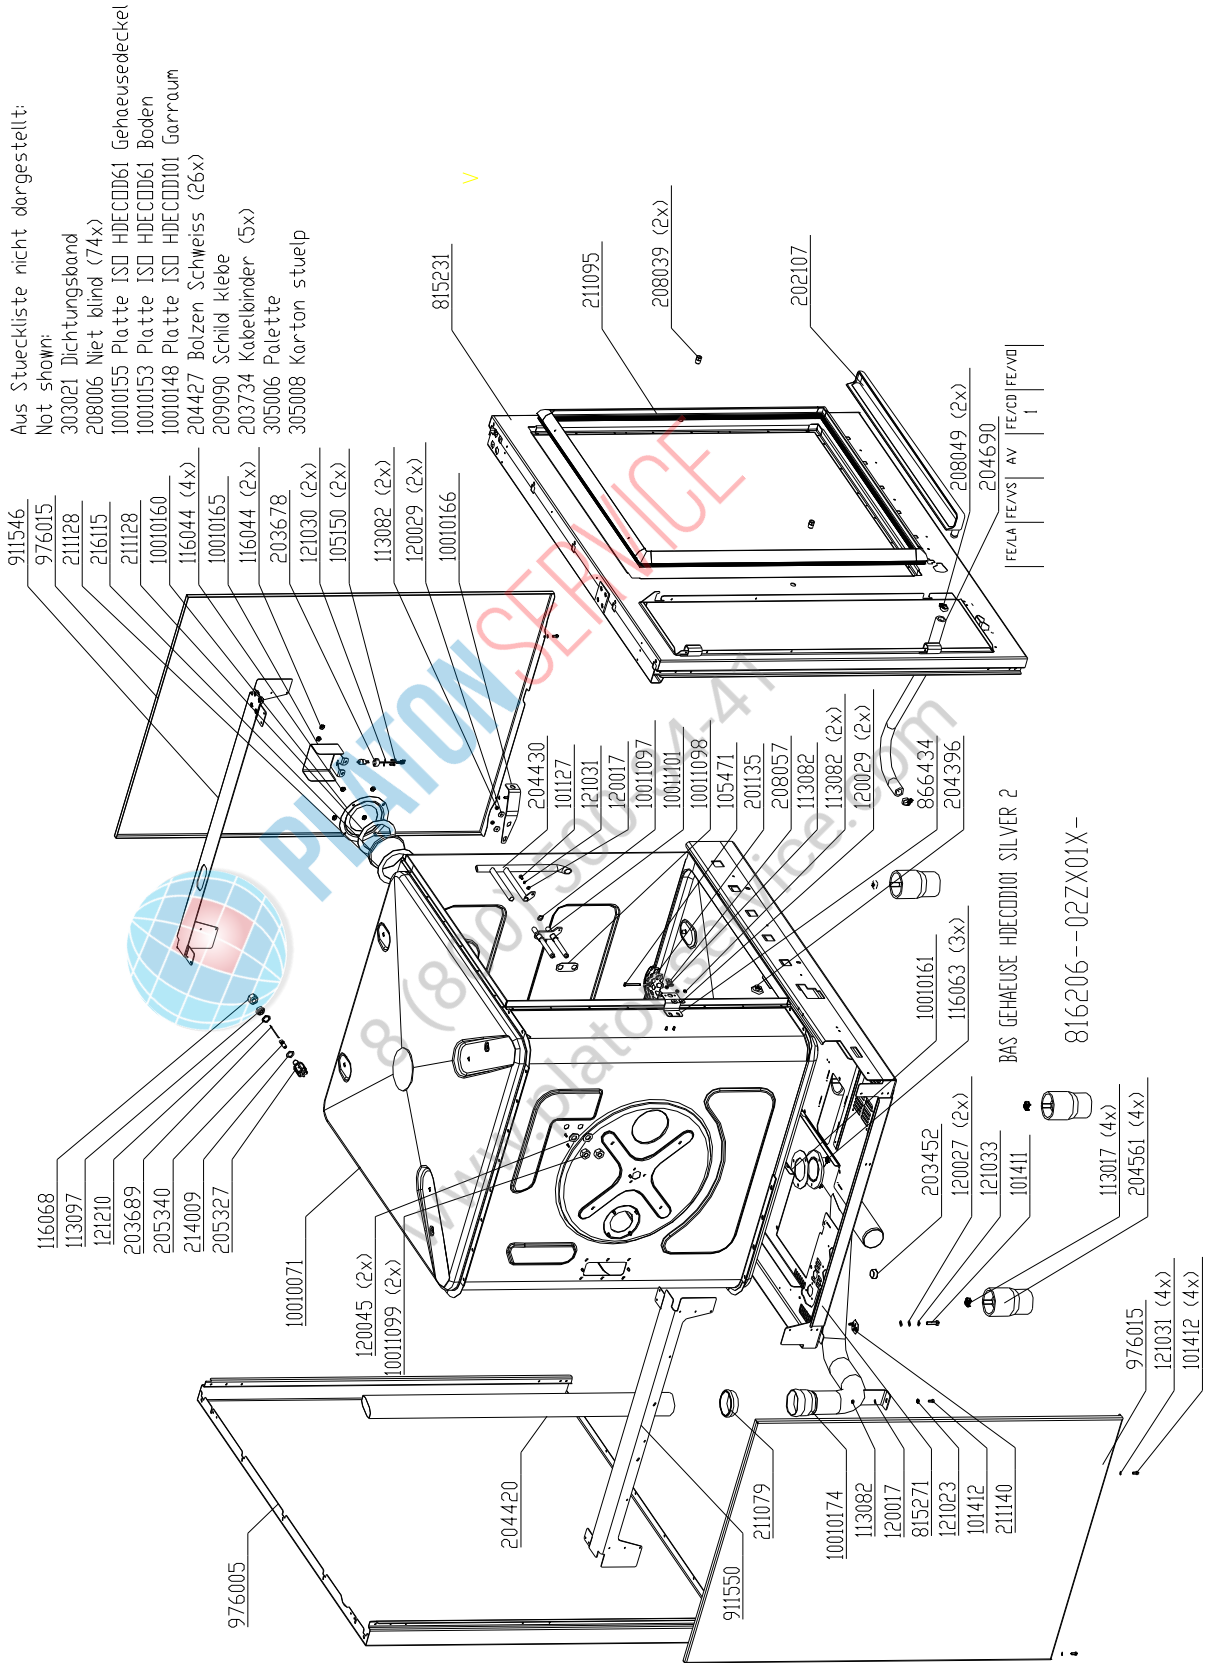
Chassis 10.x Electric Silver2 Valid from S/N 11208883 (August 2011)

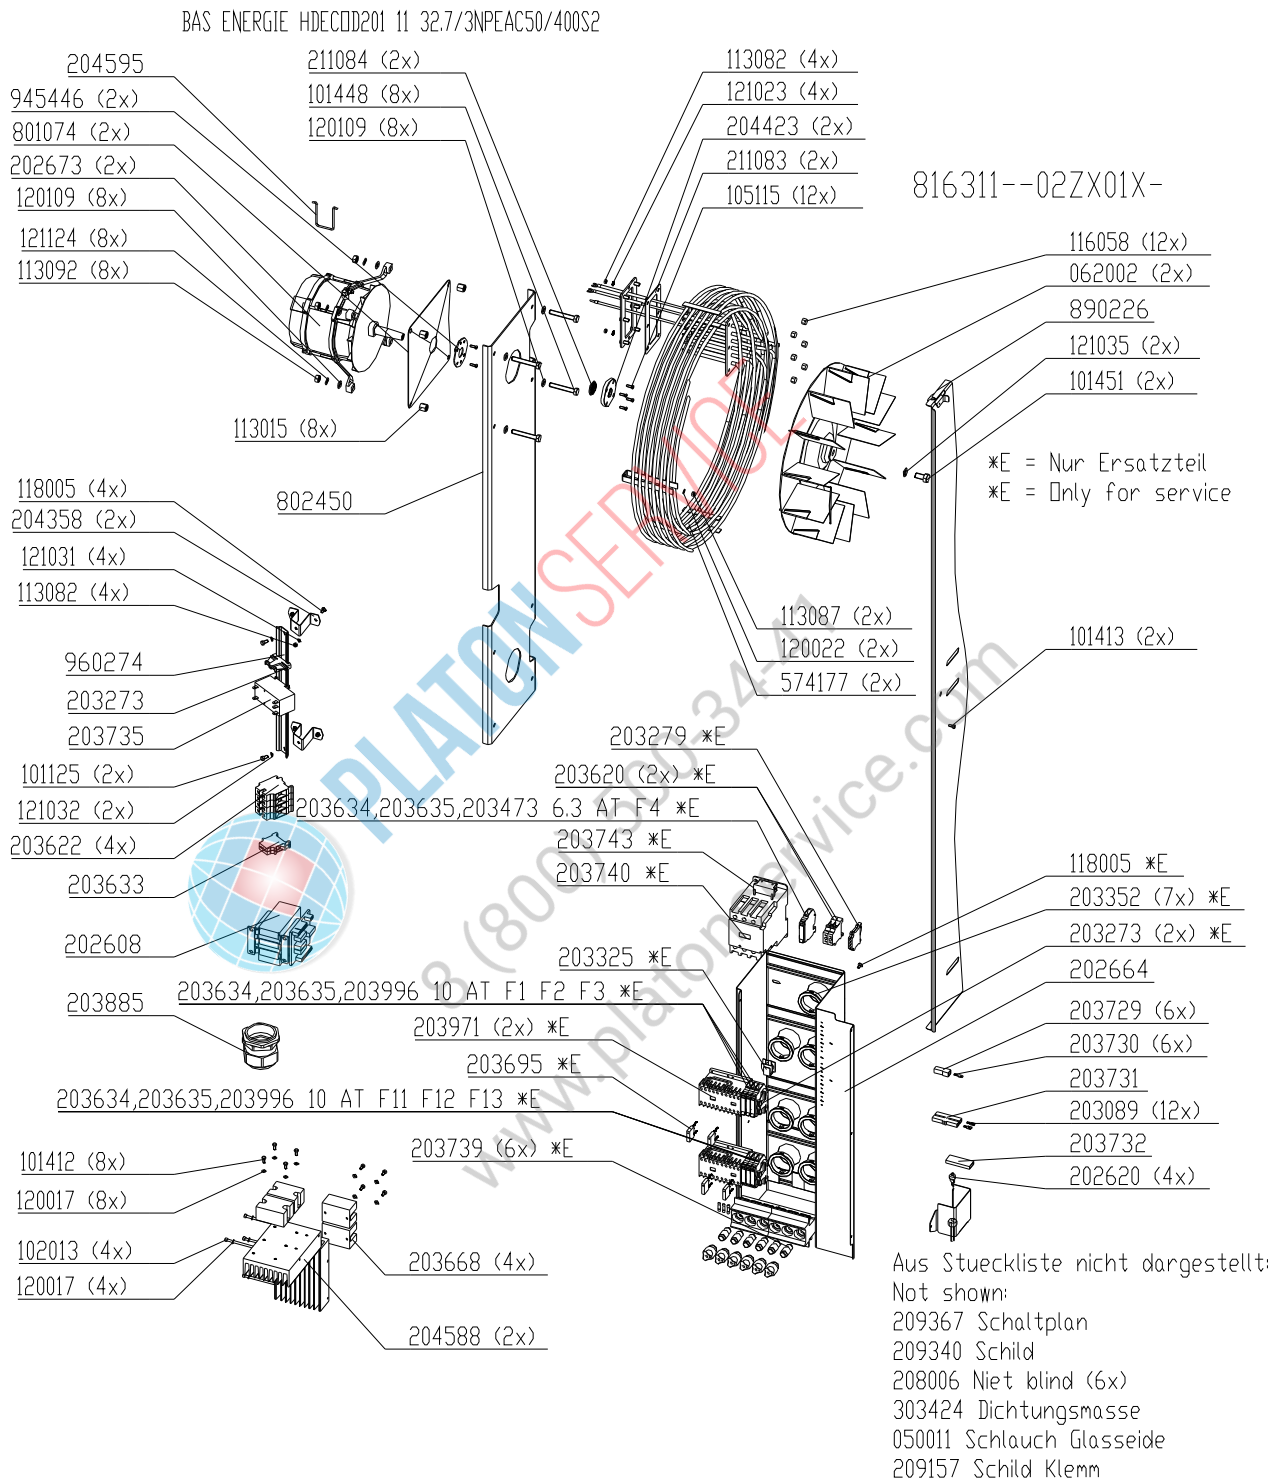
Electric assembly 3NPE 400V HD20.1 Silver2

Bis (until) S/N 08022075 (August2008) Transformator (transformer) #203818
Ab (from) S/N 11212250 (October 2011): #945446 → #945661, #204423 → 204681,
#202620 → #203679

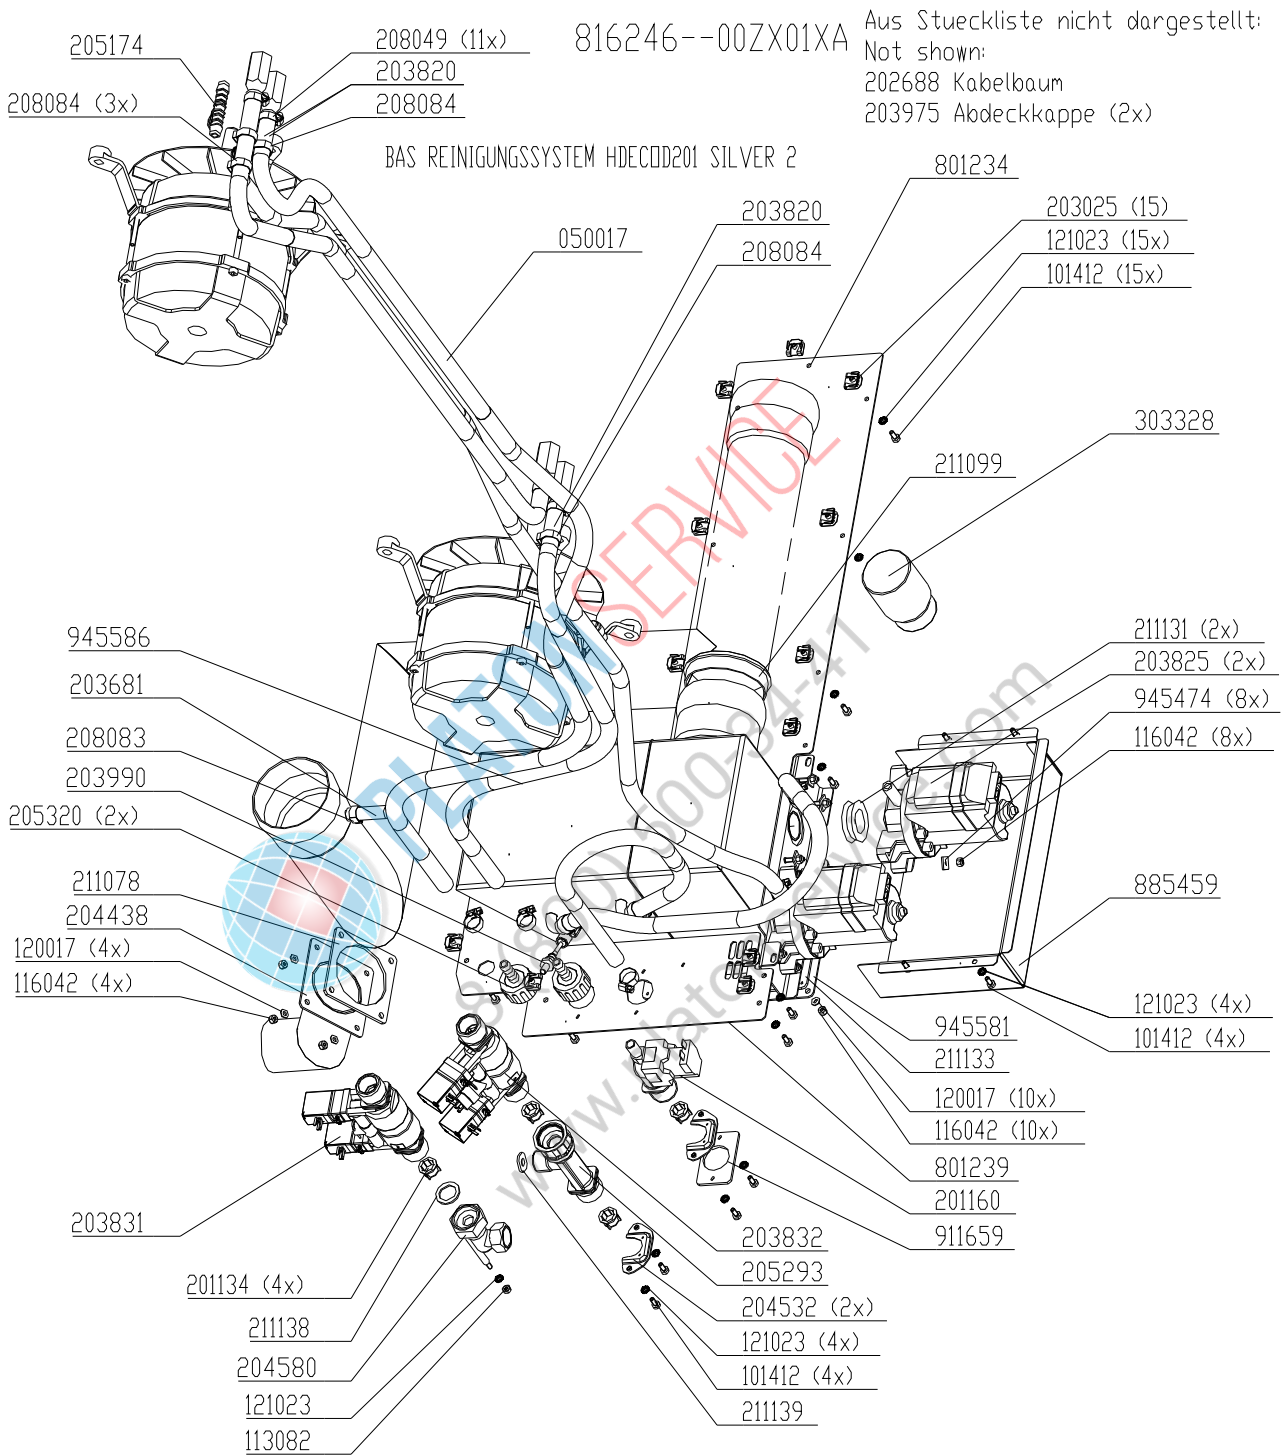
Water assembly with WaveClean 50Hz HD20.x Silver2
